TOTAL FIRE GROUP LTD

Fire Risk Assessment

25-82 Brownley Court Wythenshawe Manchester Greater Manchester M22 4QH

25 June 2024

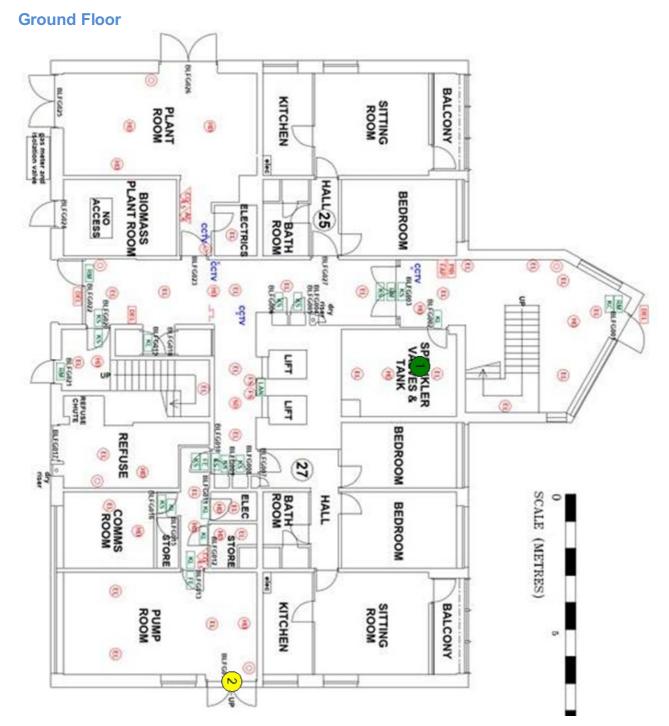
1 The Confinement of Fire - 9.1, 9.5-9.6 No Image

9.1, 9.5-9.6	The room created under the alternative stairway serving ground and first floor houses the pump and water tank for the sprinkler system. The wall between this room and the entrance hallway does not continue to true ceiling height and the fire door into the room is not fitted with intumescent strips and cold smoke seals. As this room is therefore effectively not separated from the adjoining staircase escape route and contains electrical equipment, it was recommended in a previous Fire Risk Assessment that this room should be separated from the escape route to true ceiling height by fire resisting construction and that the fire door should be provided with intumescent strips, cold smoke seals and the appropriate signage. Following the receipt of the previous Fire Risk Assessment, WCHG informed Total Fire Group that prior to the installation of the sprinkler system they had sought advice from a fire safety company, High Rise Fire Safety Ltd in regard to compartmentation. Their advice was that the risk of a fire in the sprinkler tank room is very low and provided that the room is kept sterile and checked on a regular basis there is no requirement for the room to be separated from the escape route by fire resisting construction. During this assessment, no access to the area was gained, however, it is reasonable to assume that the situation remains unchanged. The advice provided by Total Fire Group remains the same, however, WCHG has decided to follow the advice of High Rise Fire Safety Ltd. The area at the time of the assessment is provided with signage informing persons not to store any items in this location. Photo reused:
