EXTERNAL FAÇADE REPORT

BIRCHTREE COURT ROWLANDSWAY M22 5RY

February 2018

WYTHENSHAW COMMUNITY HOUSING GROUP

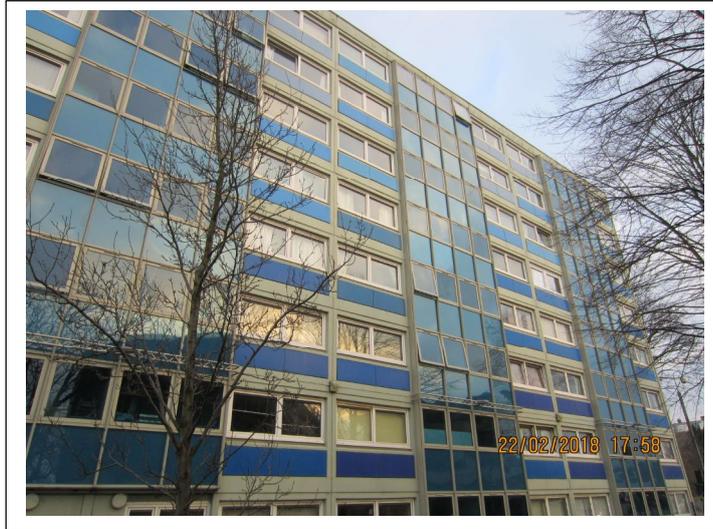
There is no cladding affixed to the external façade of the premises but there are additions to the original as-built façade. Specifically, curtain wall glazing and aluminium frames, fixed flush to the face of the concrete structural frame and panels, were fitted approximately 10 – 15 years ago to enclose a previously open balcony. The windows and doors between the living space and balcony area remain in-situ.
